DEPARTMENT OF TRANSPORTATION

Contract #: 04-0120F4Cty: SF/ALA Rte: 80 PM: 13.2/13.9File #: 13.28**WELDING INSPECTION REPORT****Resident Engineer:**Pursell, Gary**Address:** 333 Burma Road**City:** Oakland, CA 94607**Report No:** WIR-006520**Date Inspected:** 29-Apr-2009**Project Name:** SAS Superstructure**OSM Arrival Time:** 700**Prime Contractor:** American Bridge/Fluor Enterprises, a JV**OSM Departure Time:** 1530**Contractor:** Oregon Iron Works Clackamas, Or.**Location:** Clackamas, OR**CWI Name:** Mike Gregson, Rob Walters**CWI Present:** Yes No**Inspected CWI report:** Yes No N/A**Rod Oven in Use:** Yes No N/A**Electrode to specification:** Yes No N/A**Weld Procedures Followed:** Yes No N/A**Qualified Welders:** Yes No N/A**Verified Joint Fit-up:** Yes No N/A**Approved Drawings:** Yes No N/A**Approved WPS:** Yes No N/A**Delayed / Cancelled:** Yes No N/A**Bridge No:** 34-0006**Component:** Hinge K Pipe Beams**Summary of Items Observed:**

WELDING INSPECTION REPORT

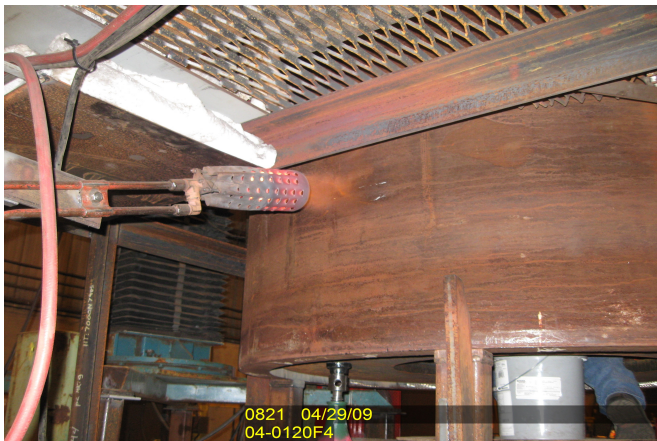
Hinge-K Pipe Beam Assembly 102A-1: 4/29/09

a111-1 Forging to a110-1 Base Plate

QA Inspector noticed this assembly 102A-1 remained idle, with a pending weld repair on weld joint #W2-13 (a110-1 to a111-1). See weld repair area picture below.....
